NTSB Investigations Addressing ADAS Technologies

August 10, 2022

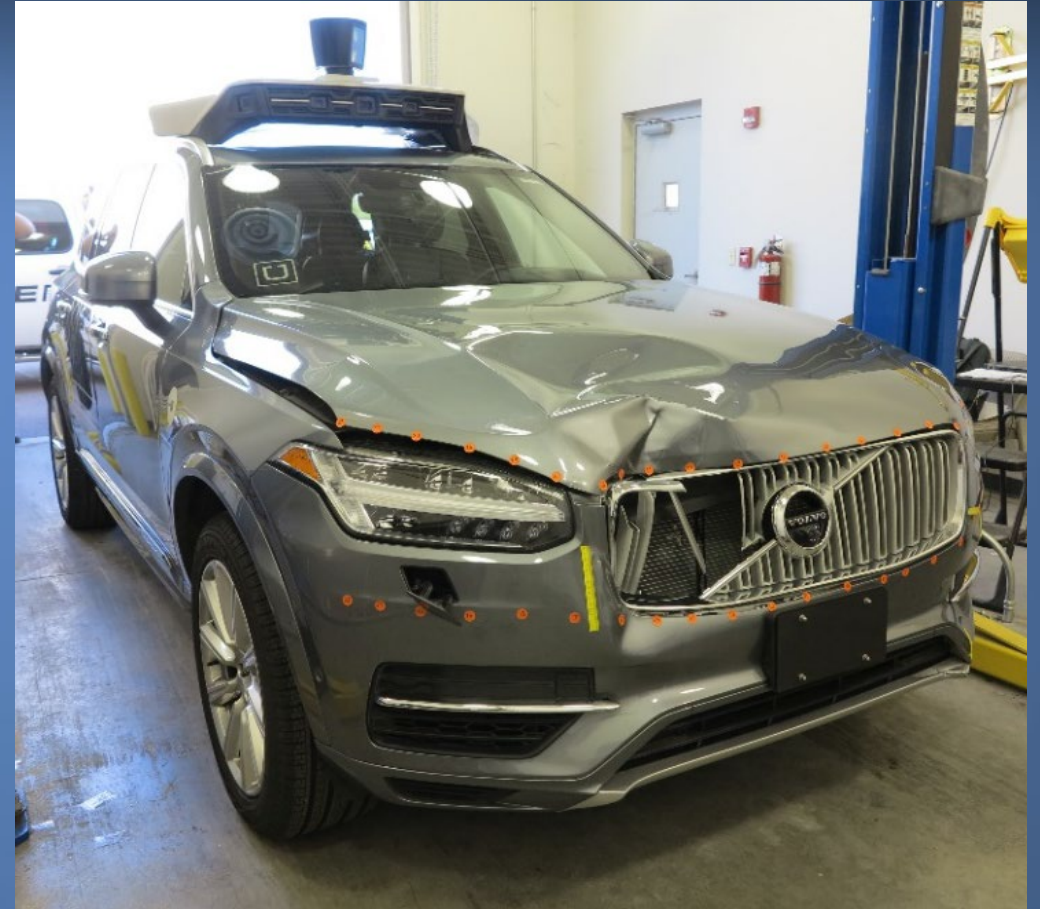
Tempe, AZ (March 18, 2018)

- Uber test vehicle based on 2017 Volvo XC90
- Uber ATG automated driving system (ADS)
- Female operator occupied the driver's seat
- Vehicle was being controlled by the ADS
- Struck pedestrian pushing a bicycle across roadway
- Pedestrian fatality

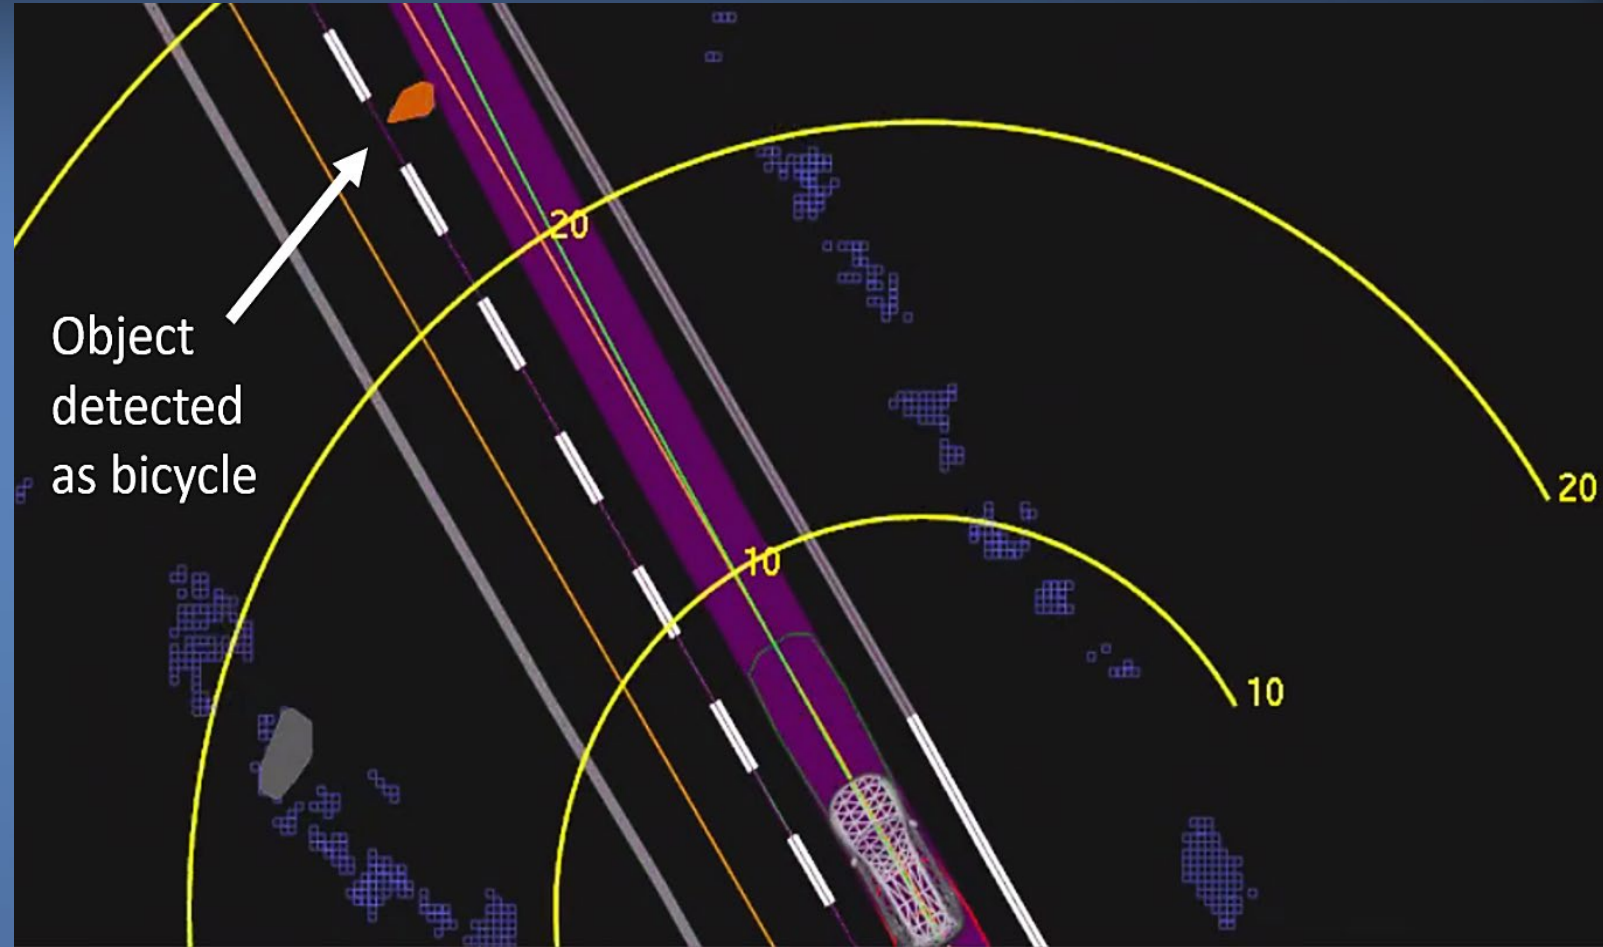
Crash Detection Sequence

- A hazard (pedestrian) detected 6 sec before impact
- Speed of 43 mph
- The hazard changed to an unknown object, a vehicle, and then a bicycle
- Emergency braking needed 1.3 s before impact
- Driver steered < 1 s
- Impact speed 39 mph

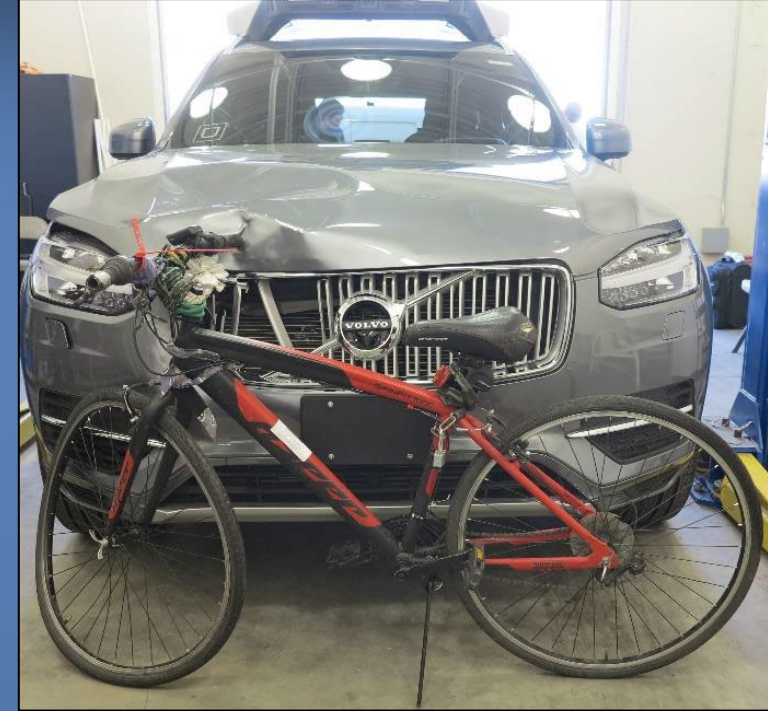
- Inability to properly classify the pedestrian pushing a bicycle
- Greater dependence on classification for object's direction of travel than the previous position of object
- System programming did not have a pedestrian classification for a person crossing the road outside of a marked crosswalk
- Emergency braking was delayed due to potential for “false positives”, instead depended on the backup driver for proper action

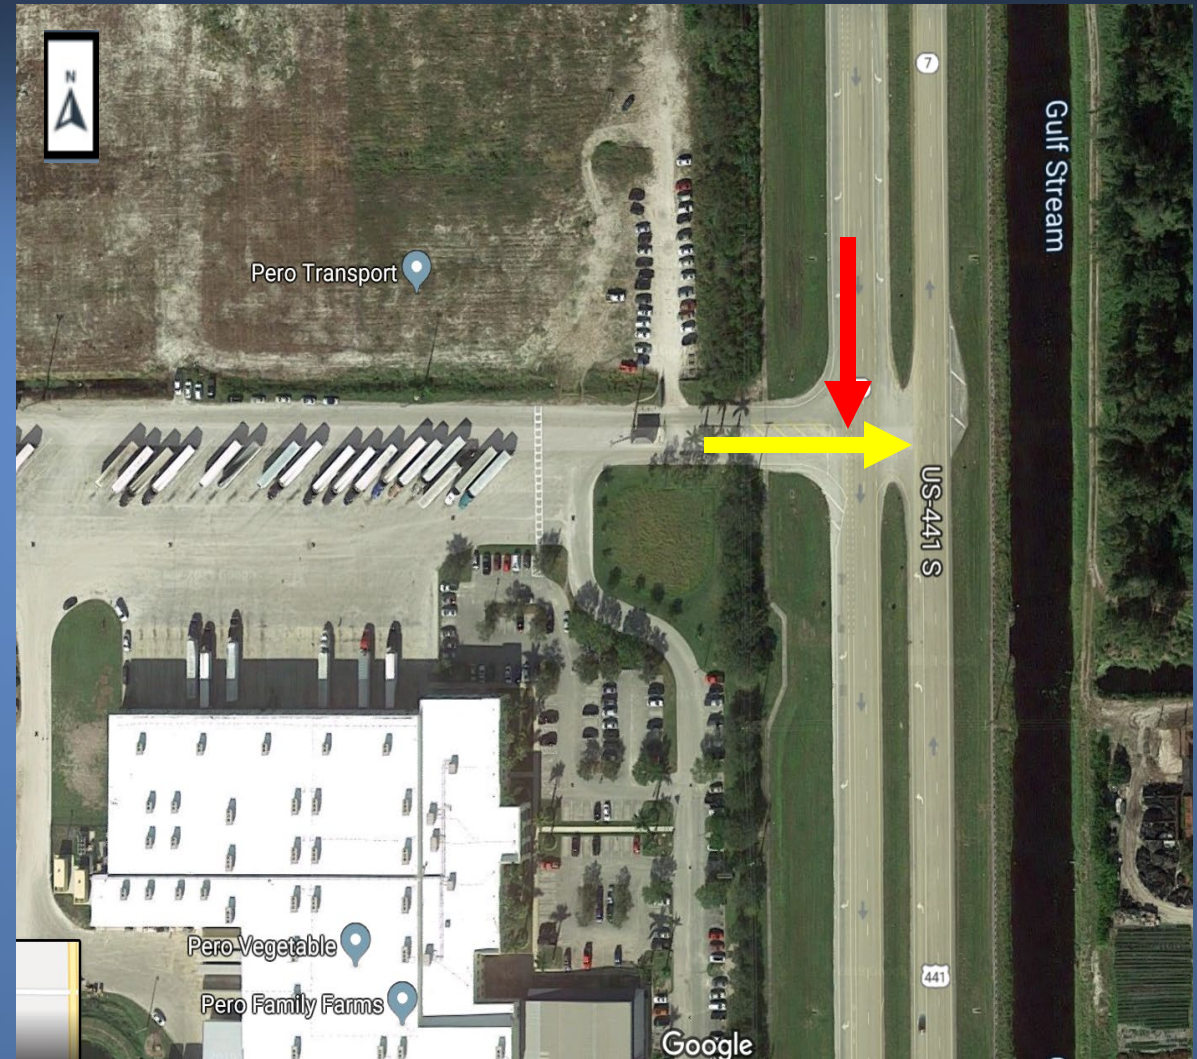
Delray Beach, Florida (March 1, 2019)

- 6:17 a.m. (EST)
- 2018 Tesla Model 3
- 2019 International truck-tractor in combination with a semi-trailer
- Posted speed limit 55 mph
- Tesla speed = 69 mph
- Autopilot activated 9.9 s before impact
- 1 Fatal

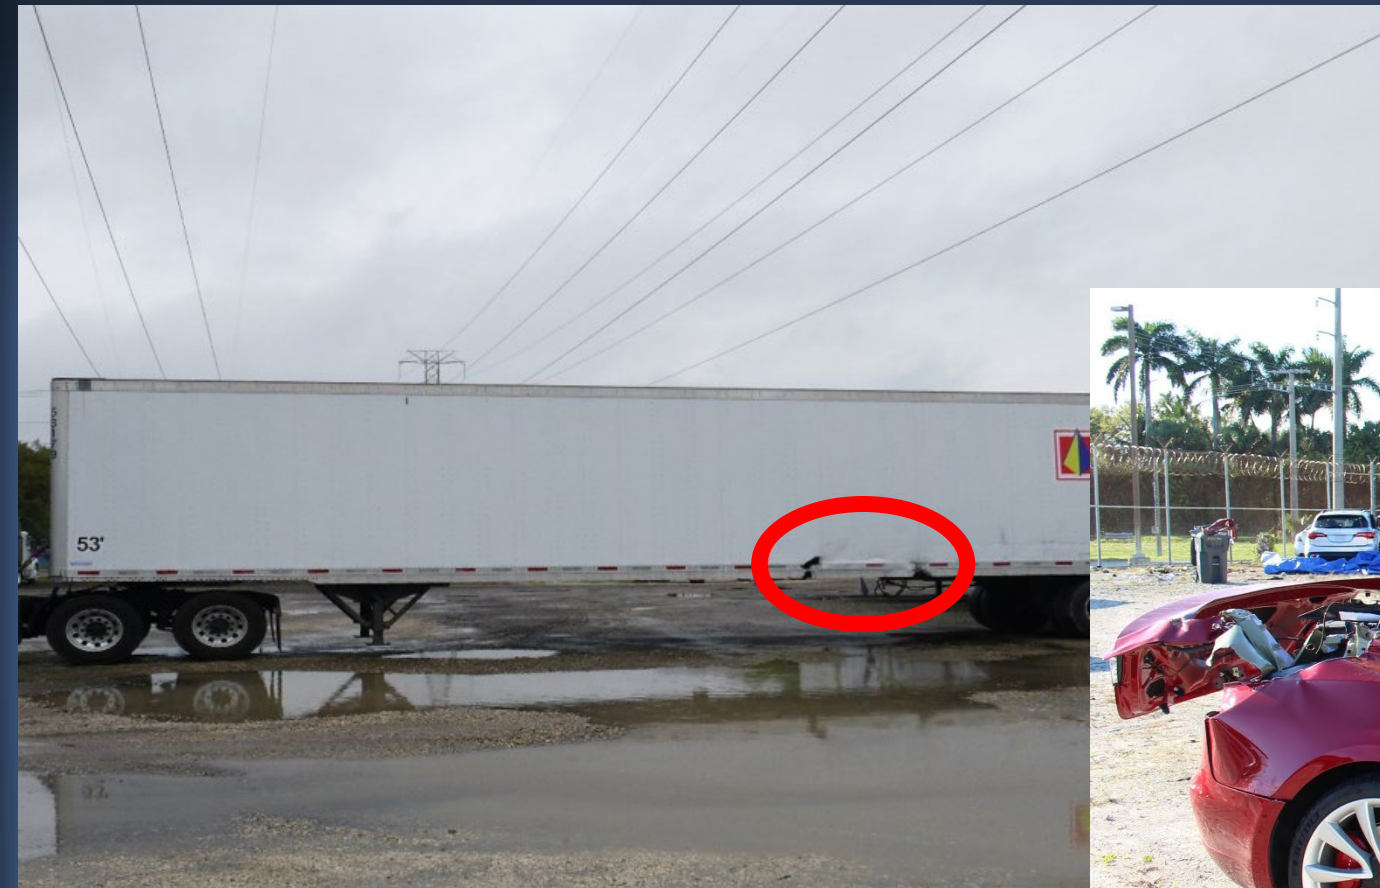
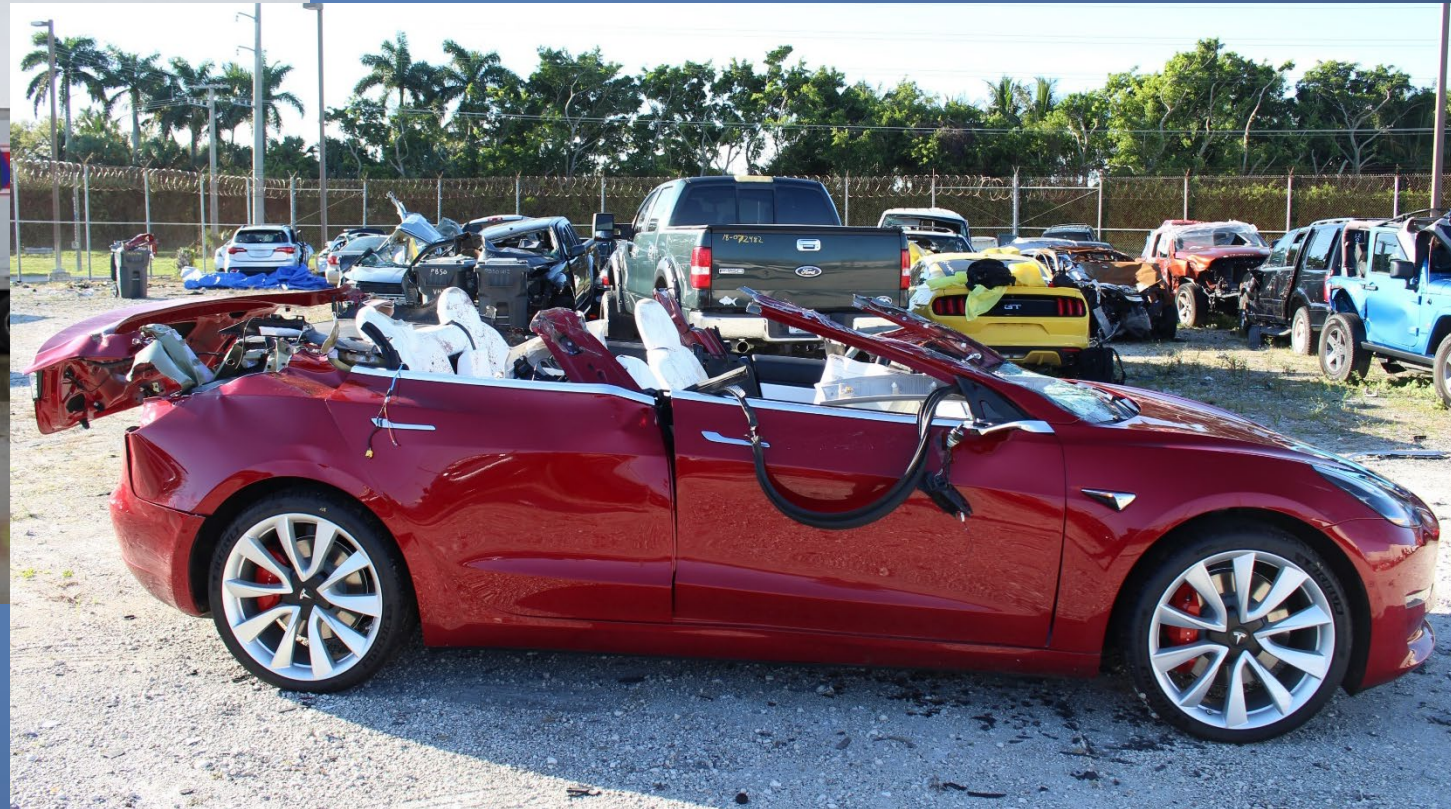
Delray Beach - Impact Damage

- Inability of the vehicle sensors to detect the crossing trailer
 - Sufficient “free space” under the trailer for vehicle to pass
- Insufficient driver monitoring system to determine driver disengagement prior to the crash

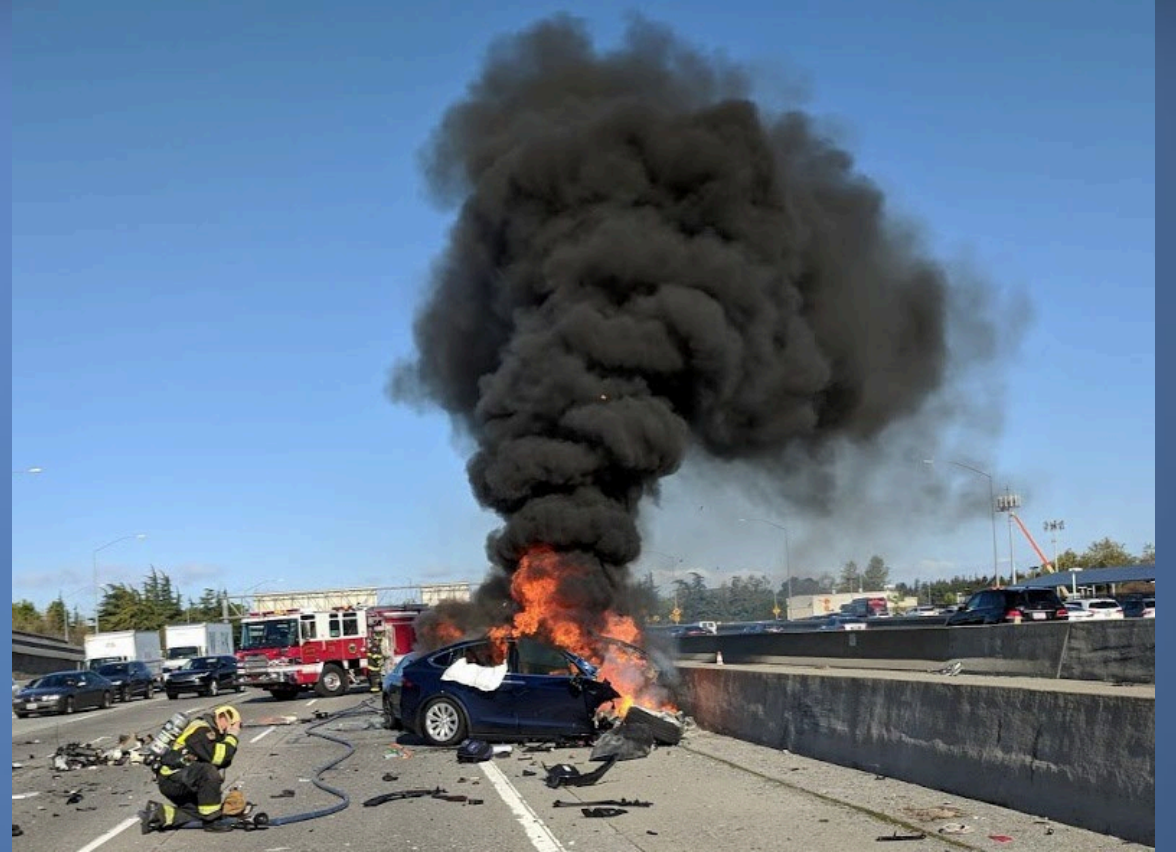
Mountain View, CA (March 23, 2018)

- 2017 Tesla Model X
- Struck previously damaged highway attenuator with Autopilot engaged
- Tesla high voltage battery fire, reignition
- Driver fatality

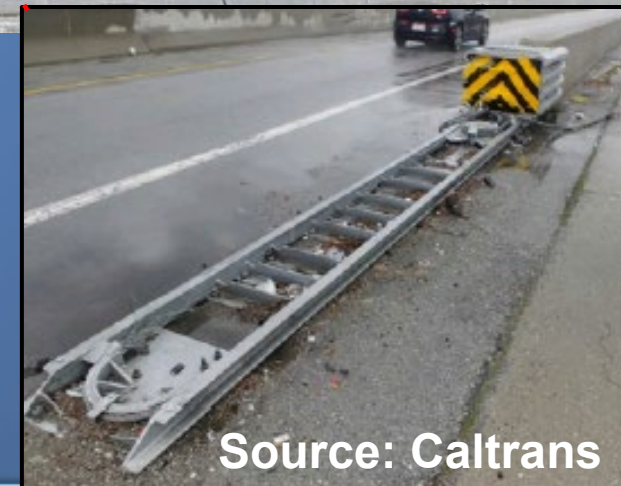
Crash attenuator was collapsed
and nonoperational prior to the
crash

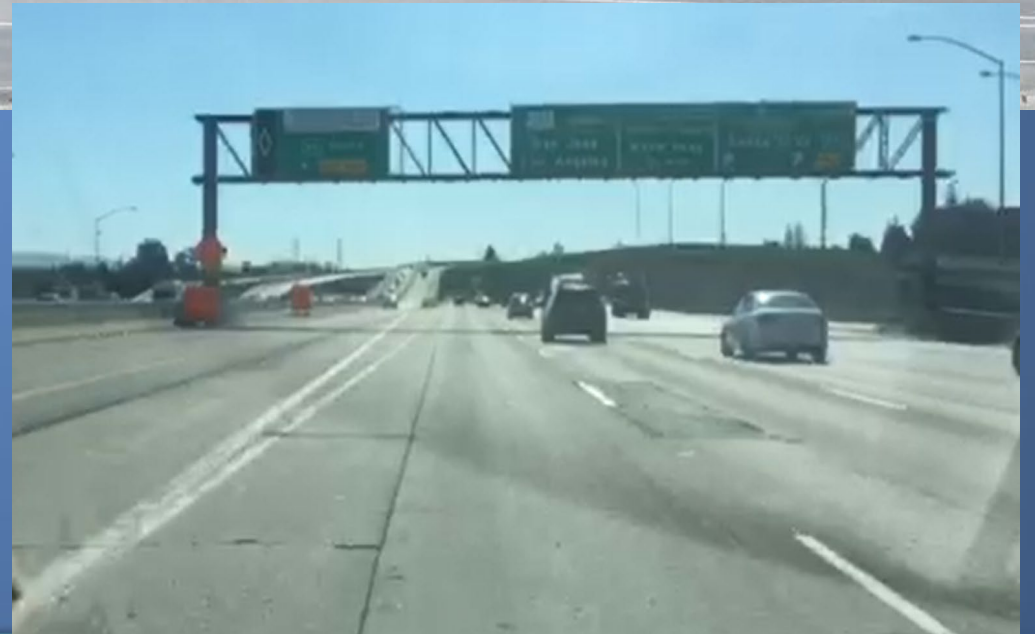
Time to crash: 7.9 seconds
Speed: 64.3 mph
Lead vehicle: 83.7 feet
Distance to crash: 748 feet

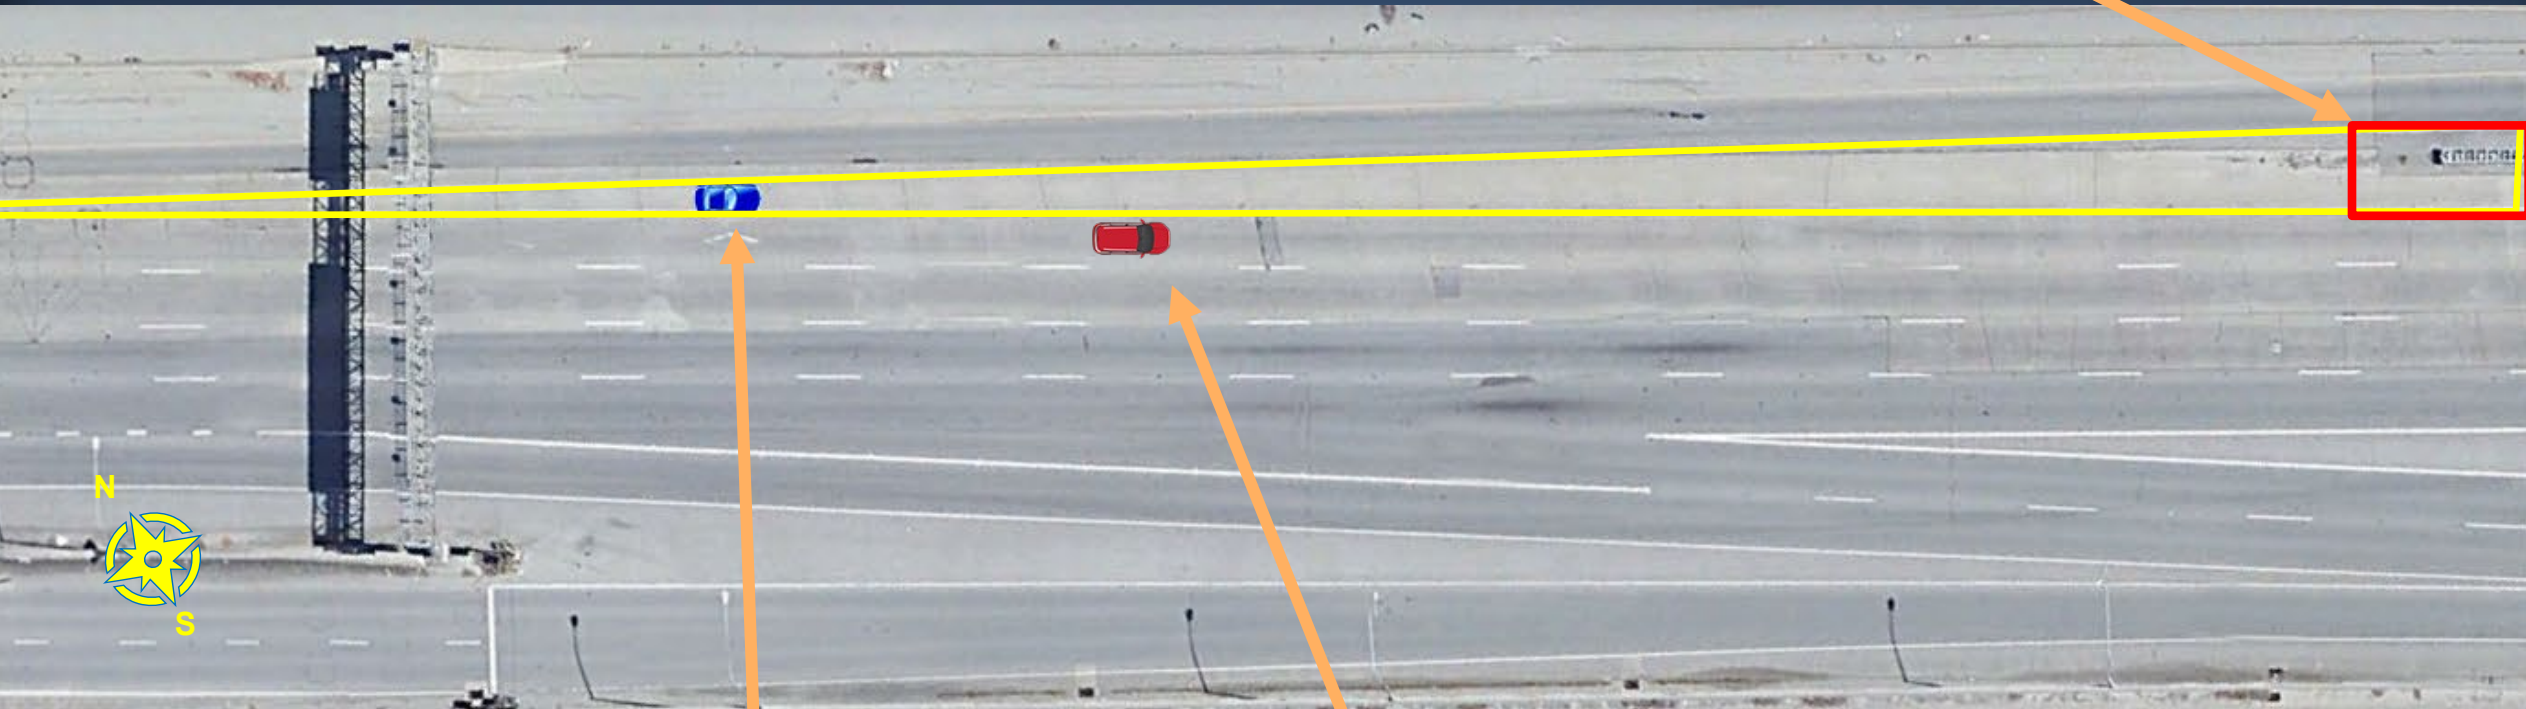
Crash Sequence

Time to crash: 3.9 seconds
Speed: 61.9 mph
Lead vehicle: None detected
Distance to crash: 375 feet
Vehicle begins to accelerate
Hands-off steering wheel indicated

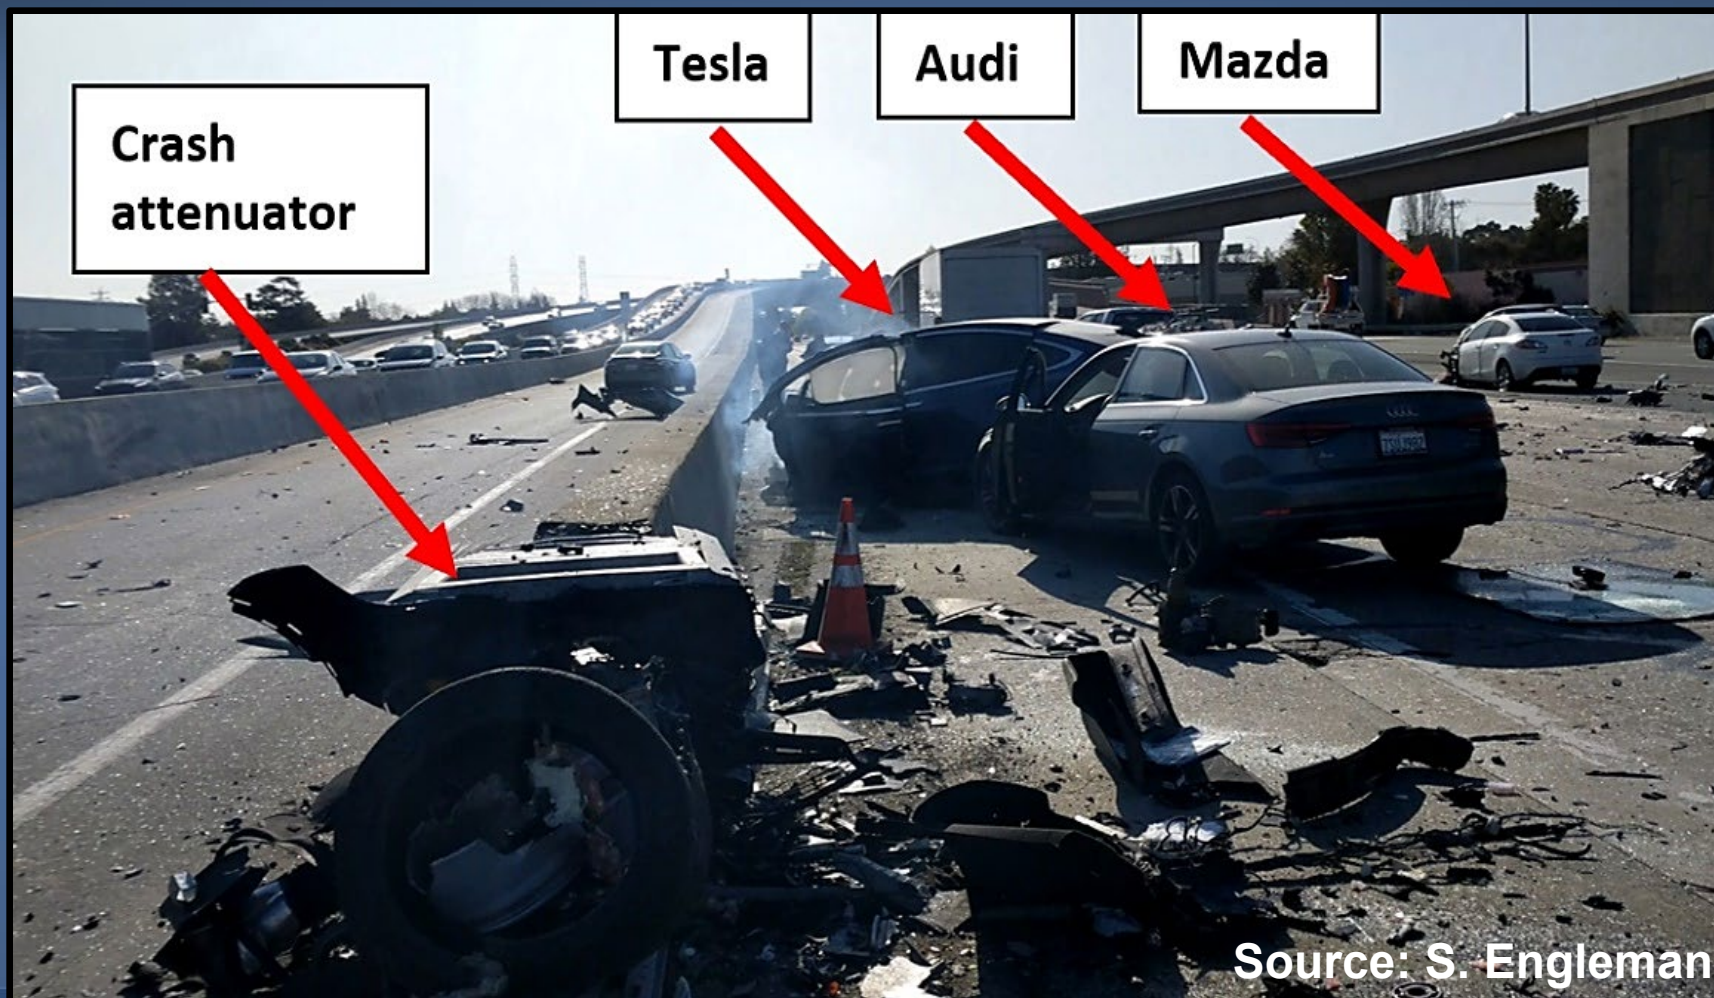
Crash Sequence

- Inability of the vehicle sensors to recognize poor lane markings on right side of gore
- Accelerated to preset cruise speed once the lead vehicle was not present (vehicle fully in gore area)
- Inability to recognize the damaged energy attenuator
- Insufficient driver monitoring system to determine driver disengagement prior to the crash

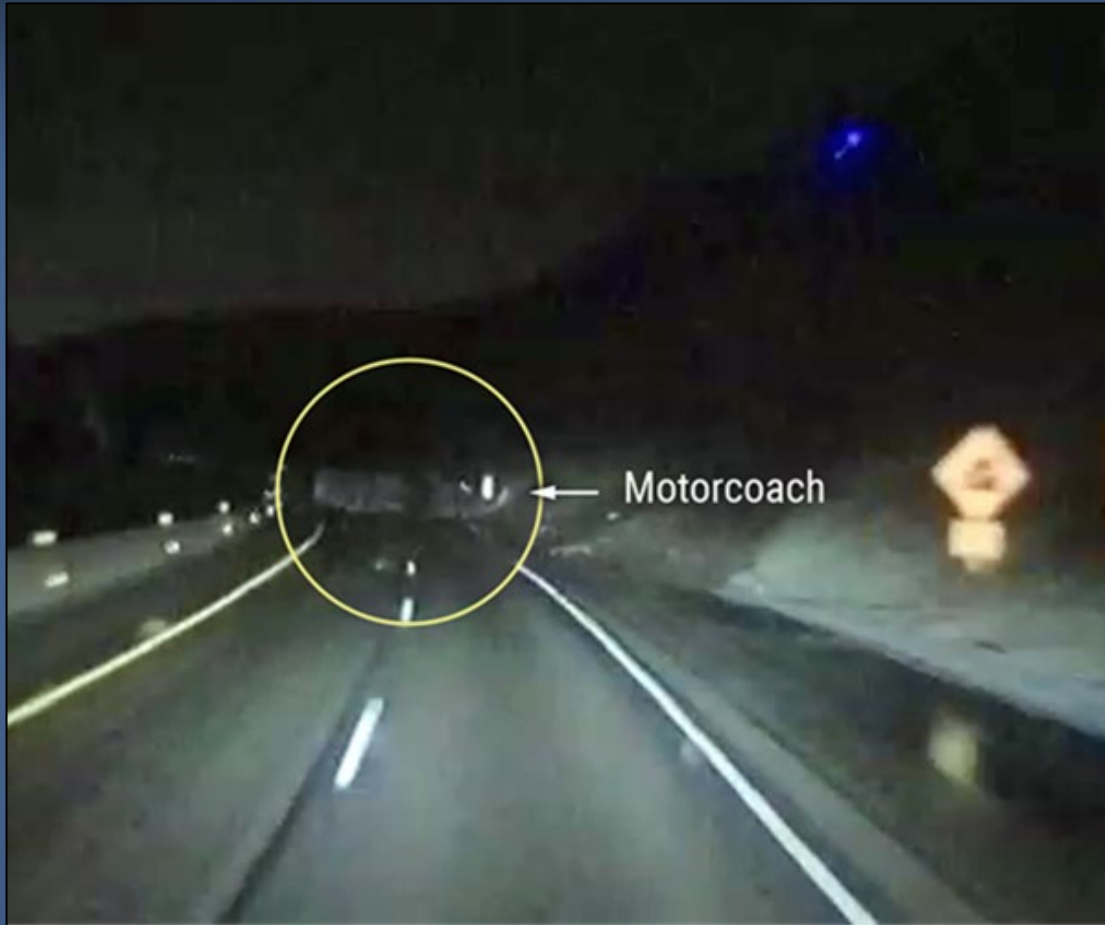
Overtaken Motorcoach

- Initial position of rest was blocking both travel lanes and shoulders
- Entered curve at 77 mph
- Light braking upon entering curve decreased speed to 70 mph
- After brakes released vehicle speed changes not associated with braking or throttle occurred
- Speed changes consistent with vehicle yawing from excessive steering inputs
- Sufficient roadway traction existed for normal travel

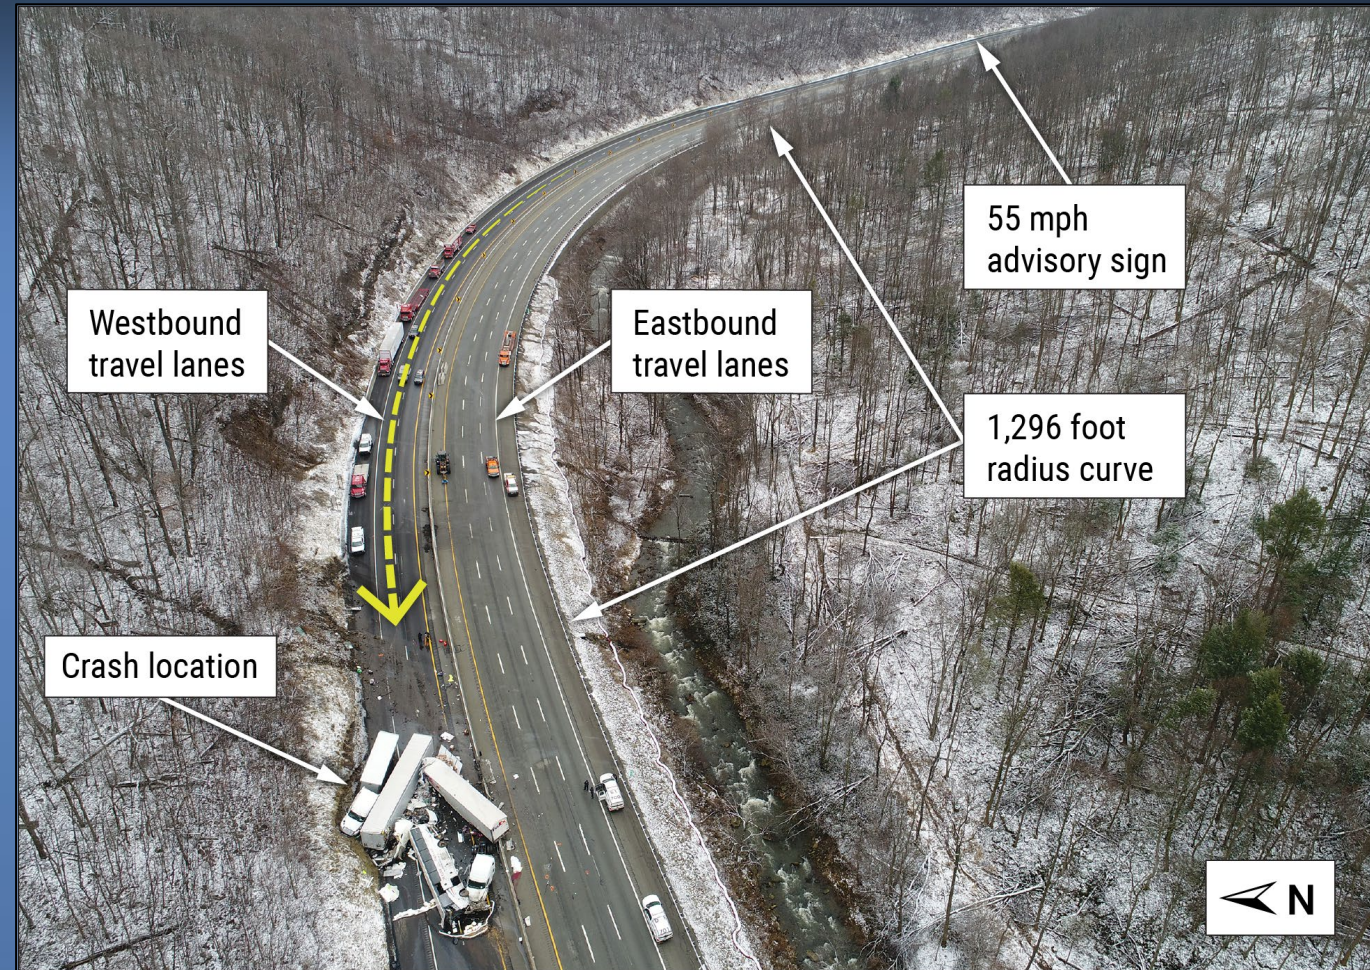
Crash Scene

- Vehicles at final rest
- Left-hand curve
- East and westbound lanes
- 55-mph warning sign

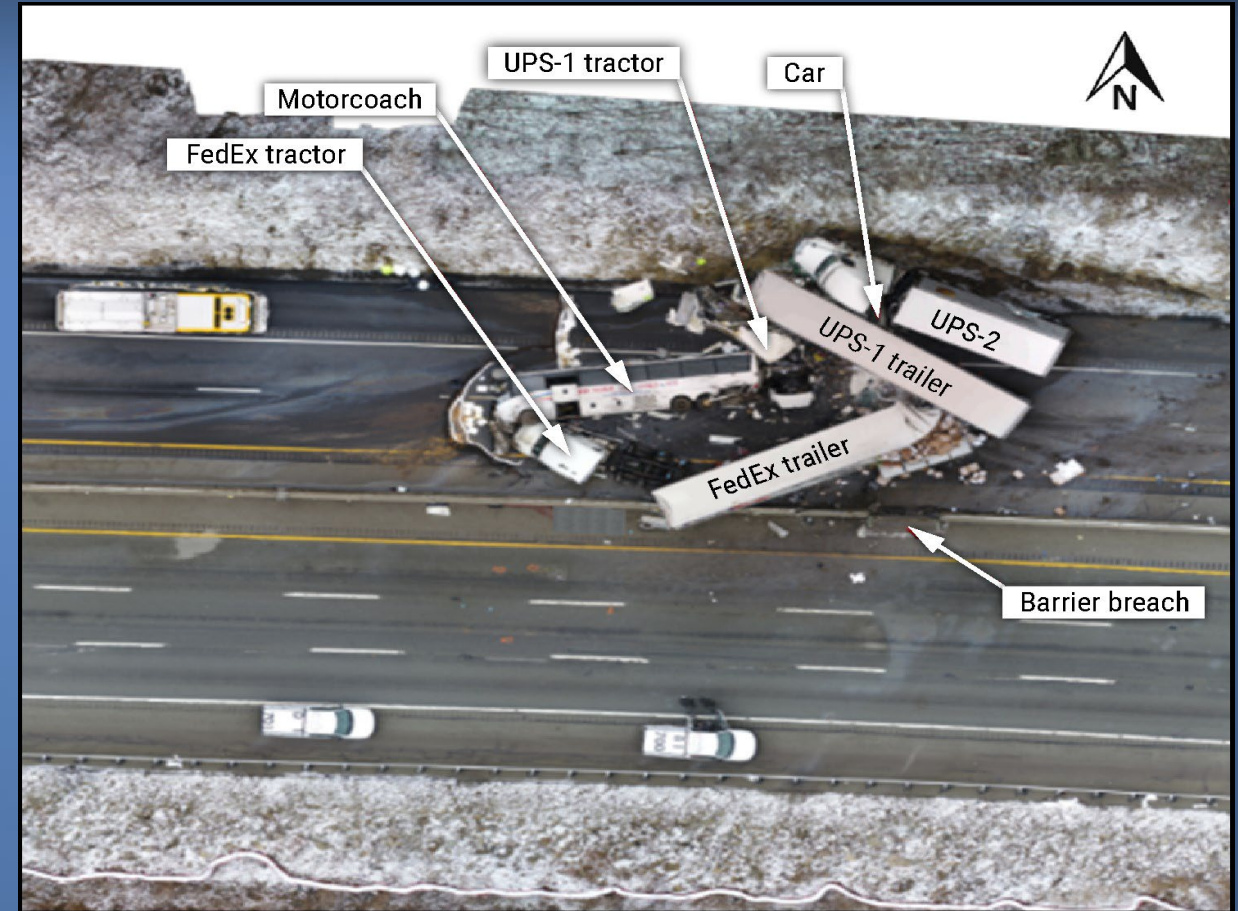
Mt. Pleasant, PA – January 5, 2020

- Final rest positions of vehicles
 - Motorcoach
 - FedEx tractor & trailer
 - UPS-1 tractor & trailer
 - Passenger car
 - UPS-2 tractor & trailer
