NTSB Investigations Addressing ADAS Technologies

August 10, 2022

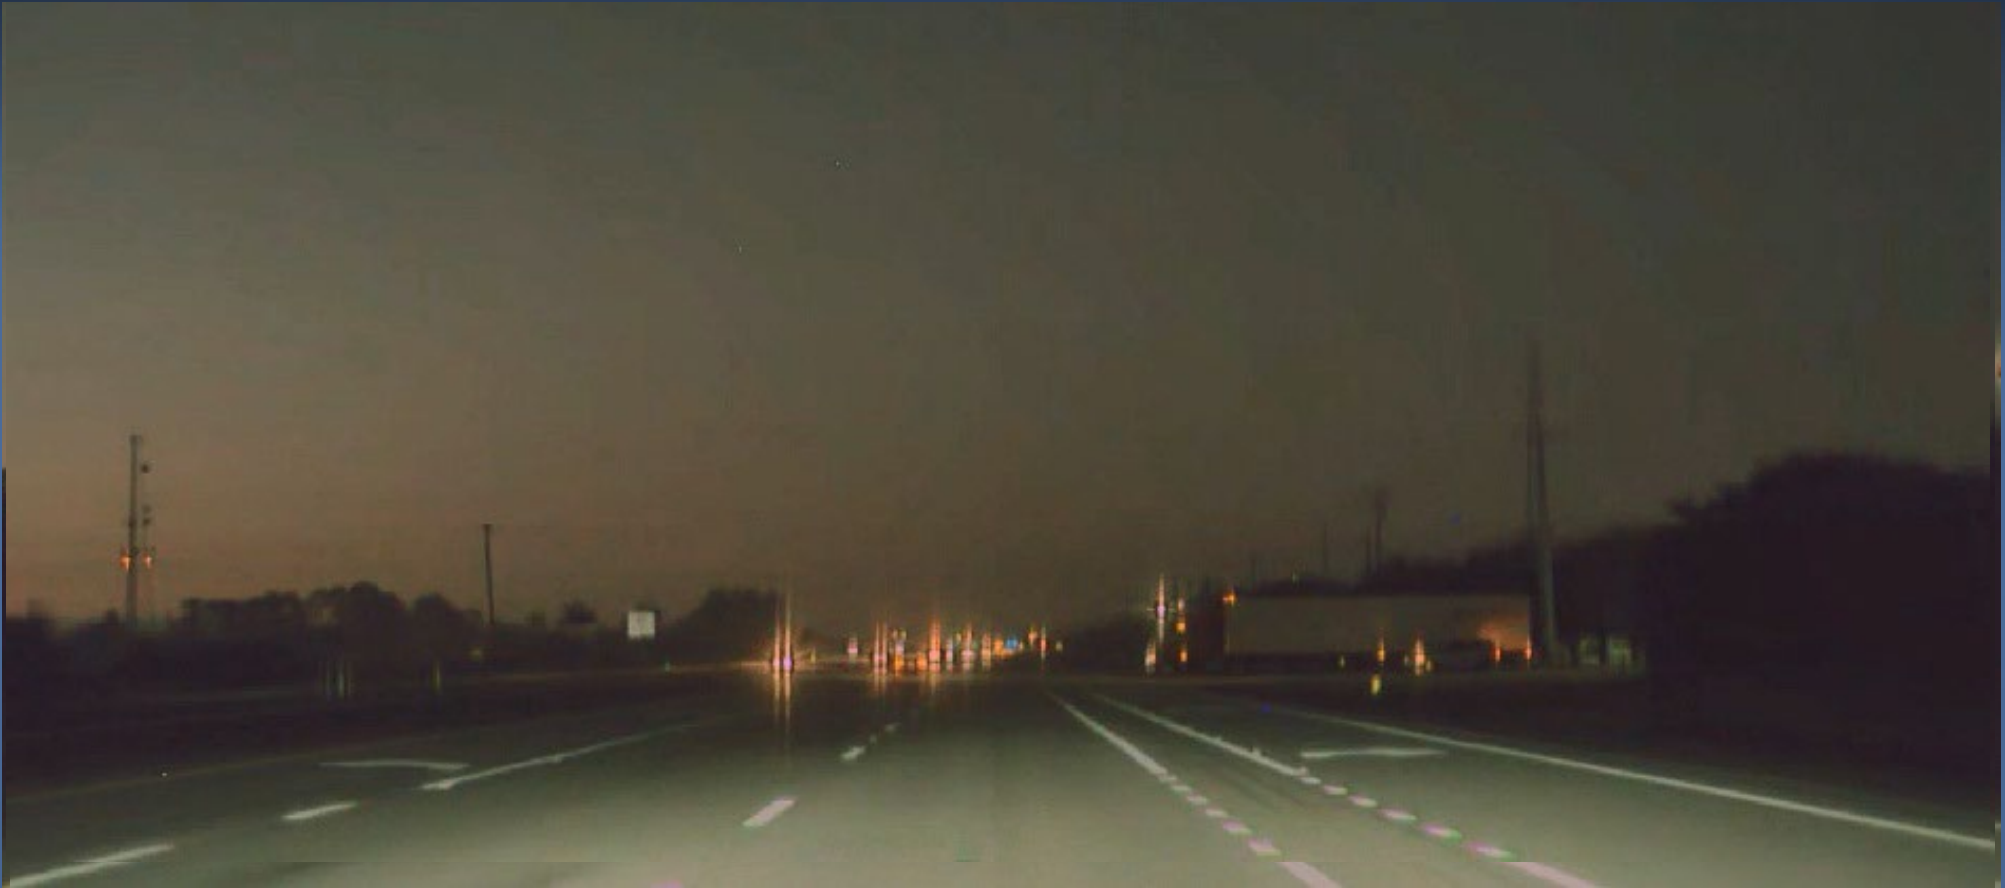
Delray Beach, Florida (March 1, 2019)

- Inability of the vehicle sensors to detect the crossing trailer
 - Sufficient “free space” under the trailer for vehicle to pass
- Insufficient driver monitoring system to determine driver disengagement prior to the crash

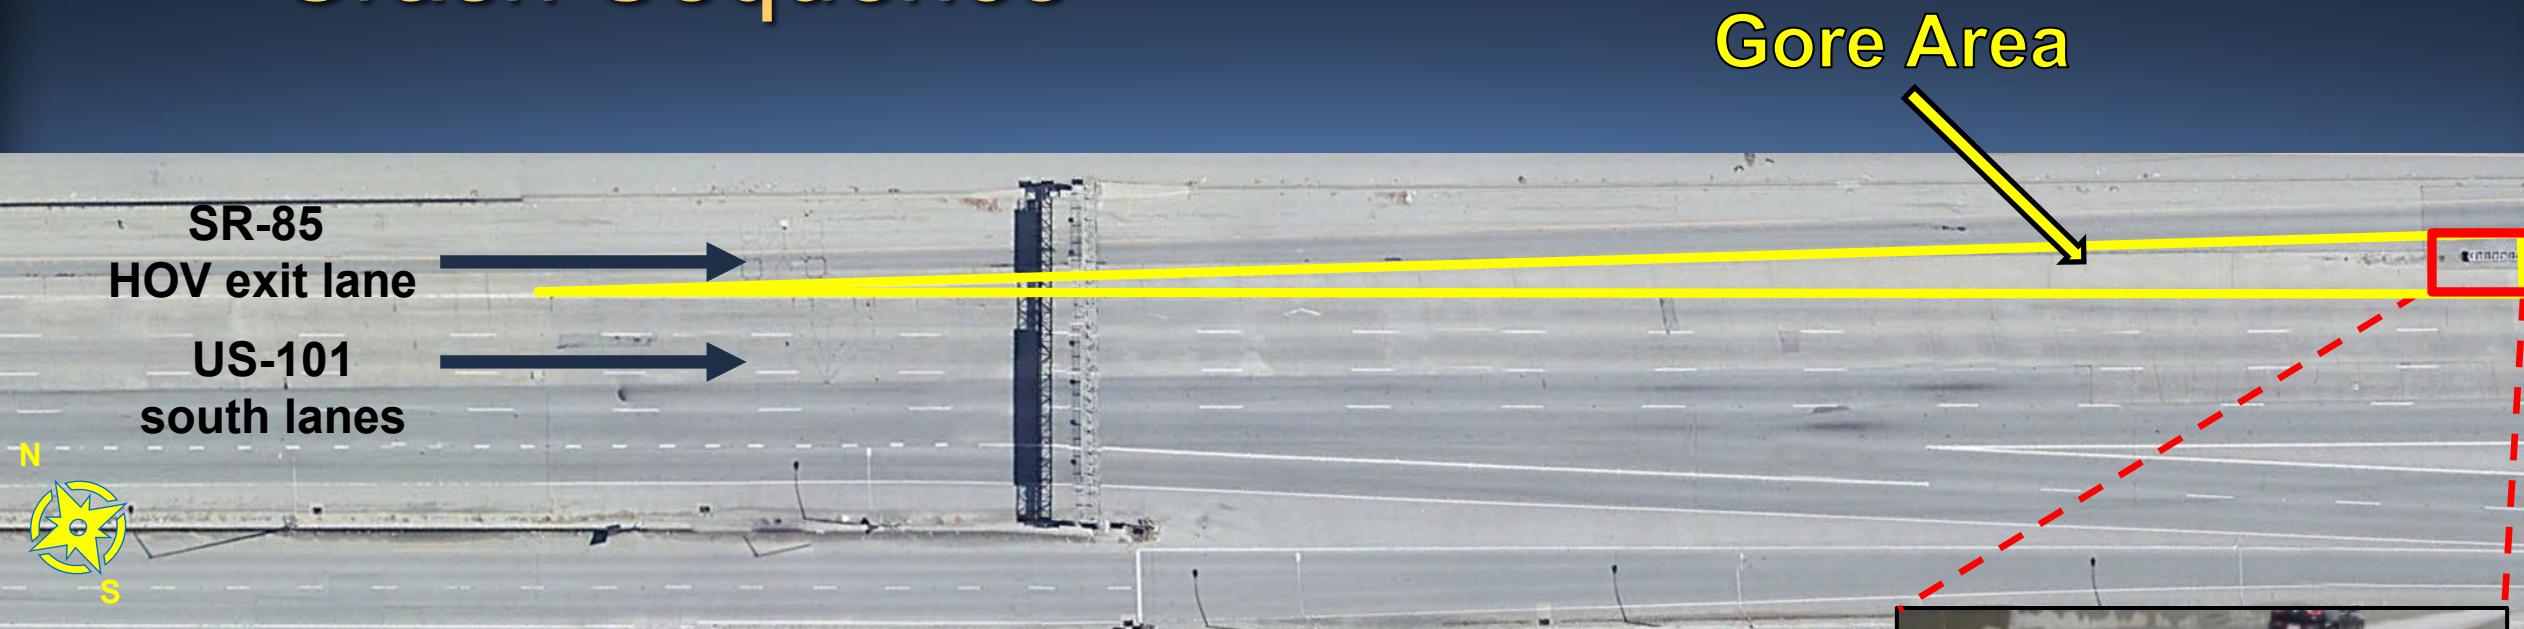
Crash Sequence

Crash attenuator was collapsed
and nonoperational prior to the
crash

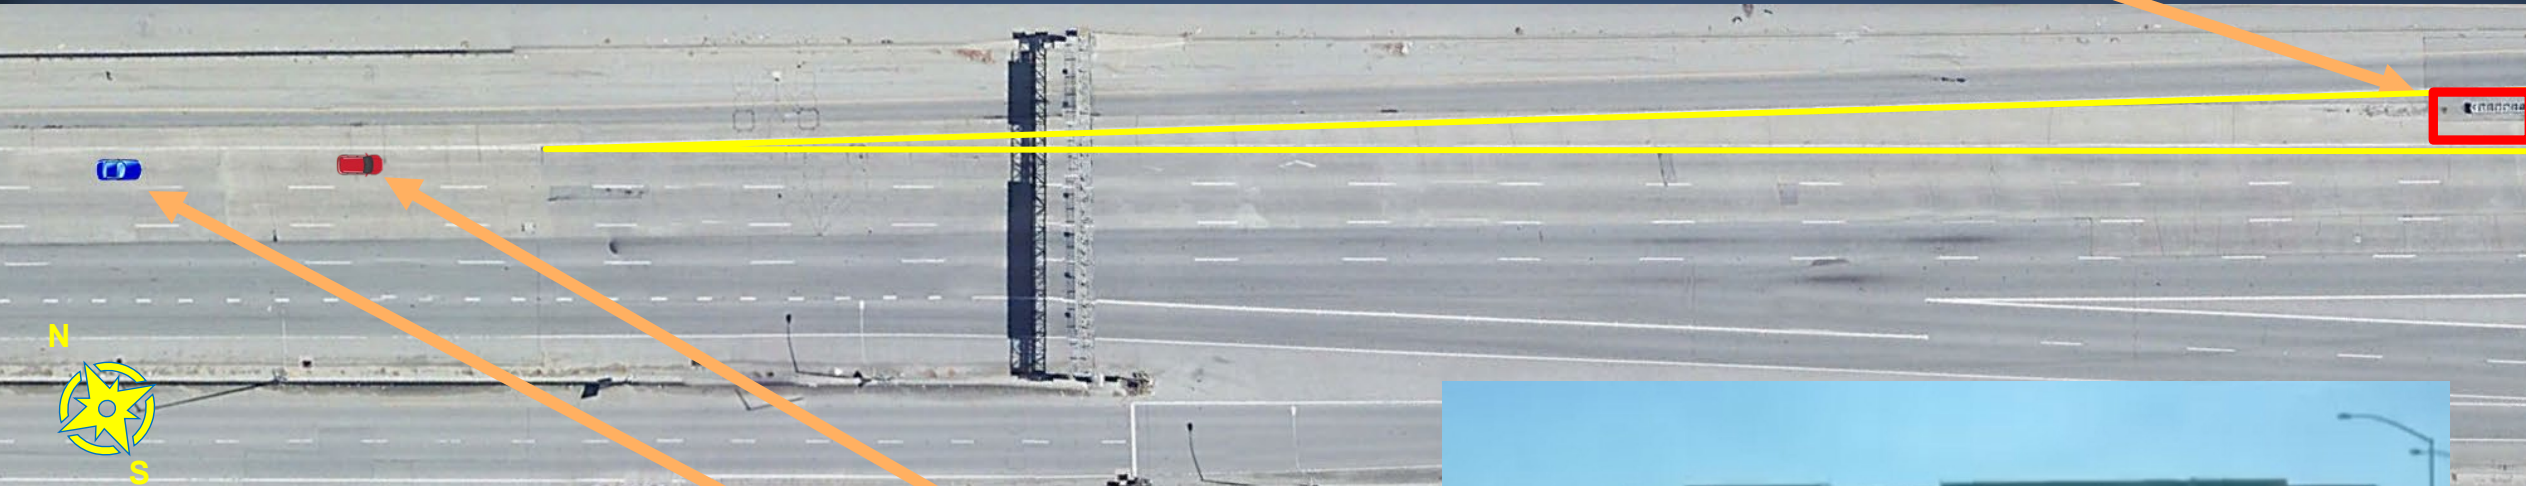
Crash Sequence

Time to crash: 7.9 seconds
Speed: 64.3 mph
Lead vehicle: 83.7 feet
Distance to crash: 748 feet

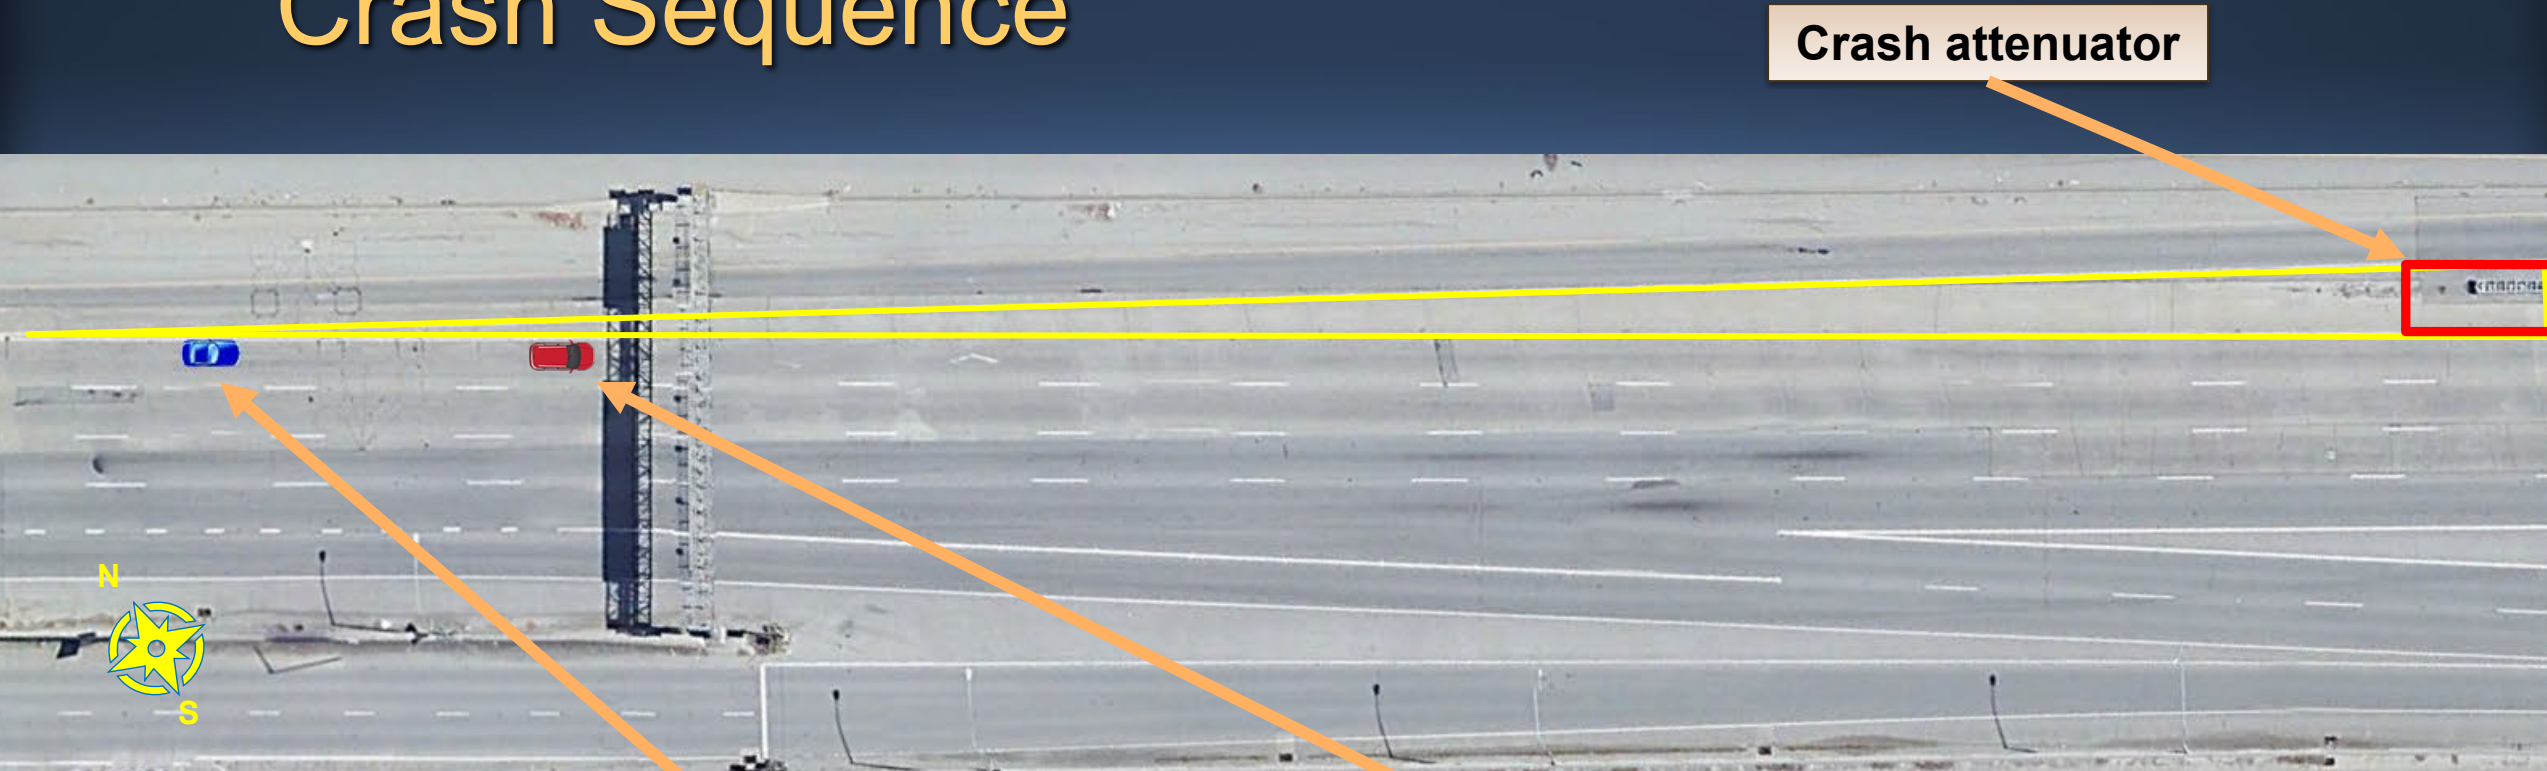
Crash Sequence

Time to crash:	5.9 seconds
Steering:	5.6 degrees left
Speed:	64.1 mph
Lead vehicle:	82 feet
Distance to crash:	560 feet
Indication:	Hands-off steering wheel

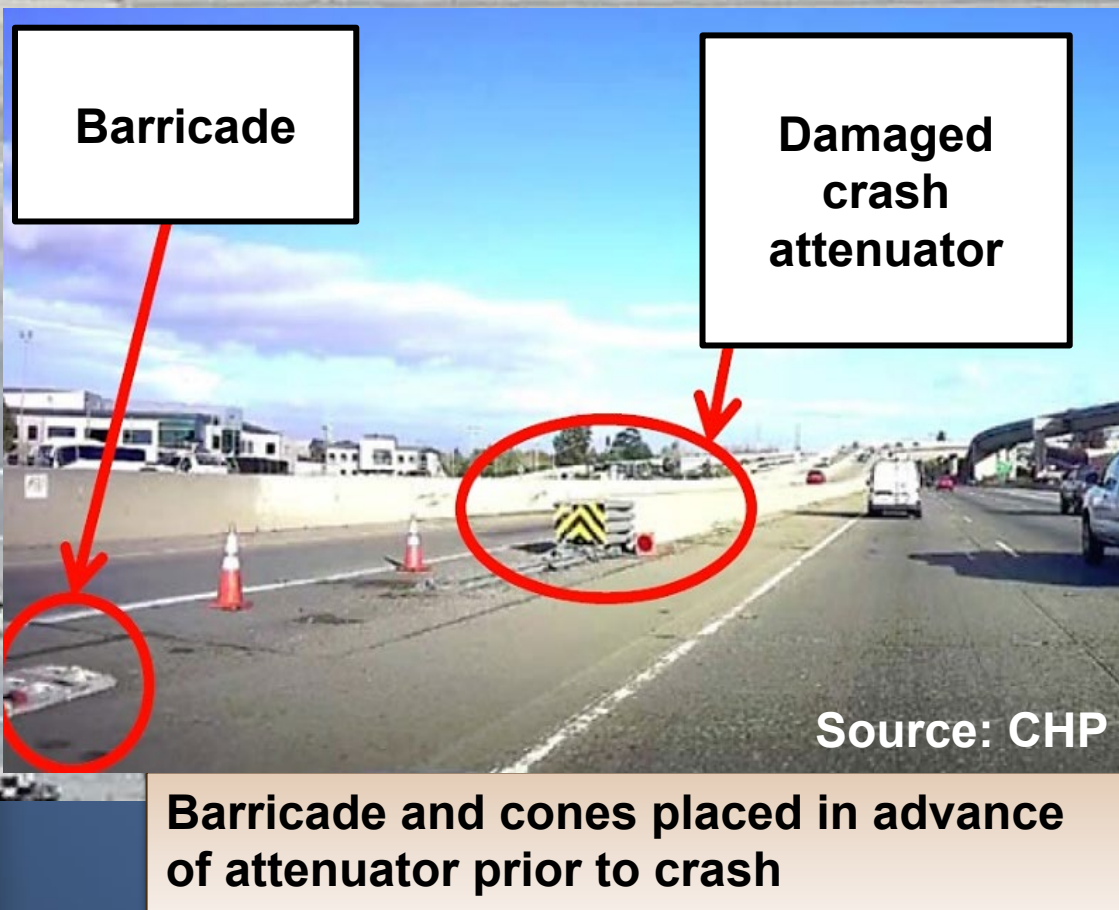
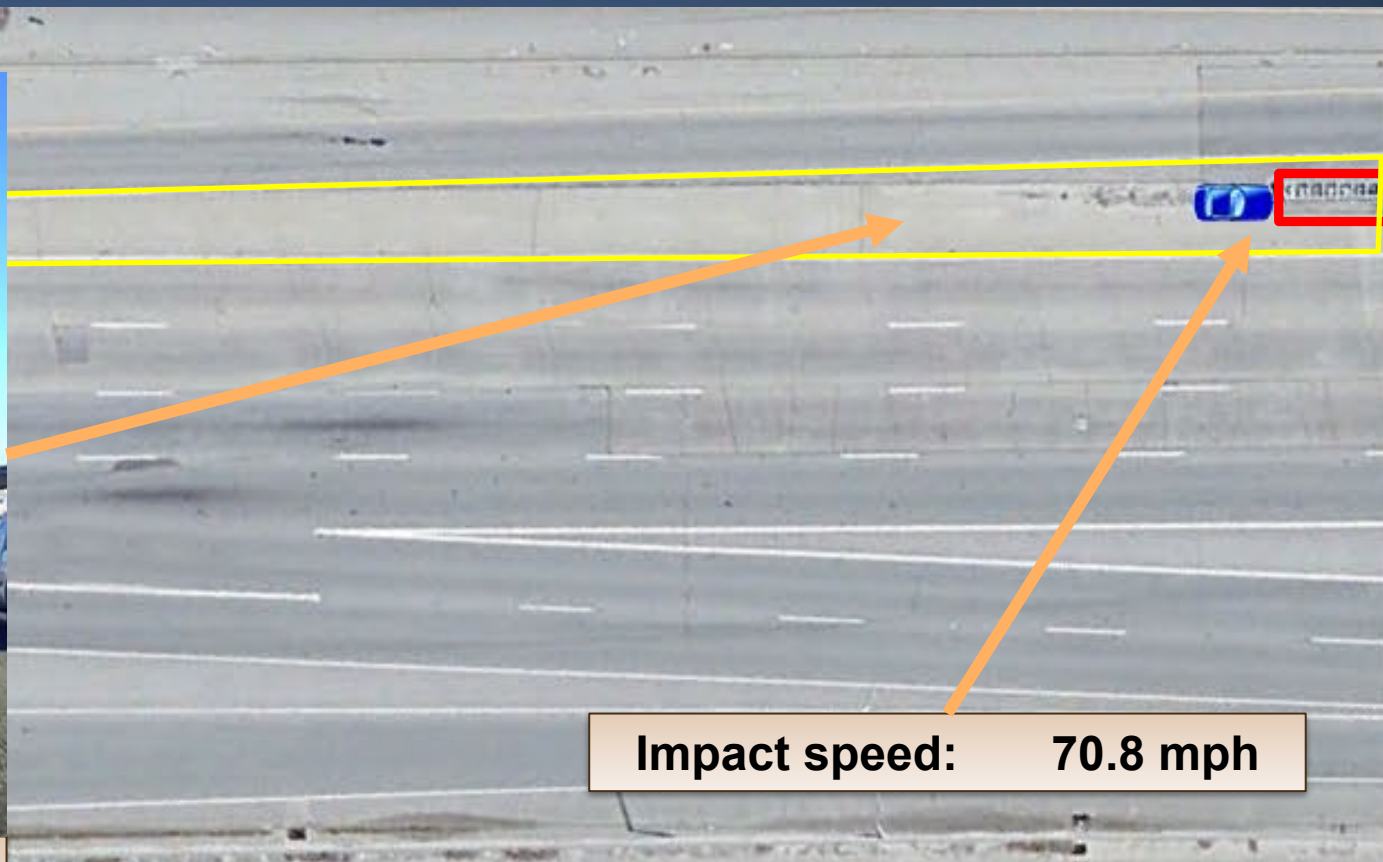
Crash Sequence

- Inability of the vehicle sensors to recognize poor lane markings on right side of gore
- Accelerated to preset cruise speed once the lead vehicle was not present (vehicle fully in gore area)
- Inability to recognize the damaged energy attenuator
- Insufficient driver monitoring system to determine driver disengagement prior to the crash
